Historic, archived document

REGION

7

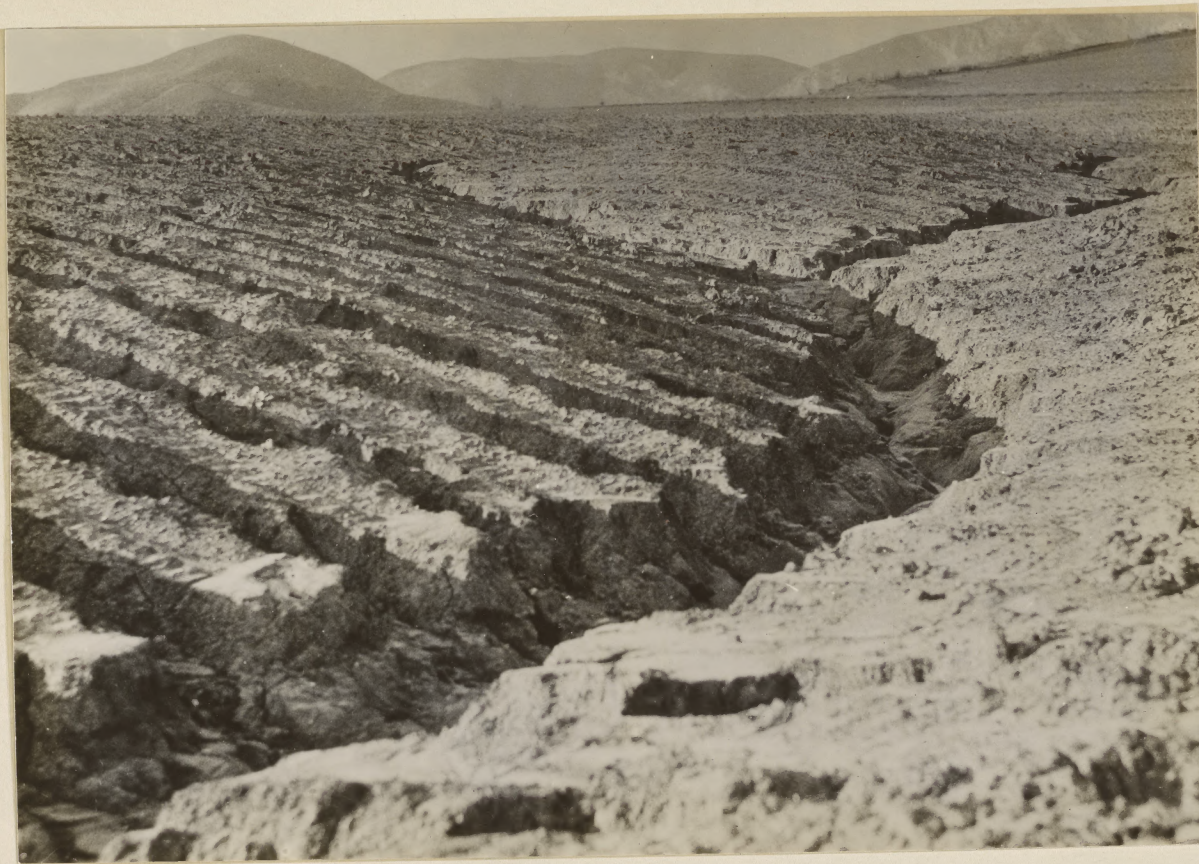
7-2 - Santa Paula, California.
EROSION - Gully.

Erosion on Lima Bean land Rincon loam, during storm of Dec. 31, 1933,
Water followed subsoil marked slopes 5 to 10%. Feb. 8, 1934.

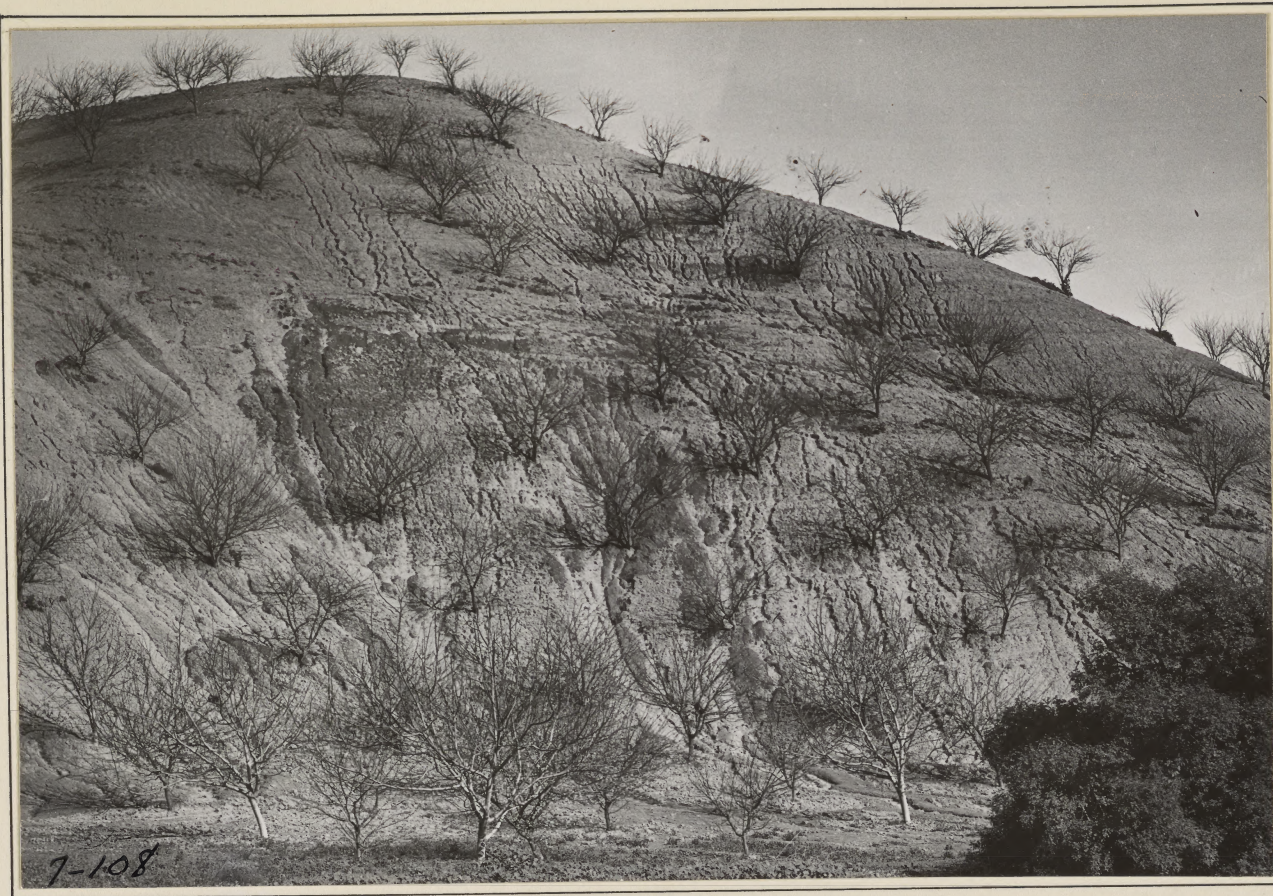
7-108 - Santa Paula, California
EROSION - Sheet

Sheet erosion in apricot orchard planted on slopes up to 55%.
Patches of weeds show tendency to control the erosion.

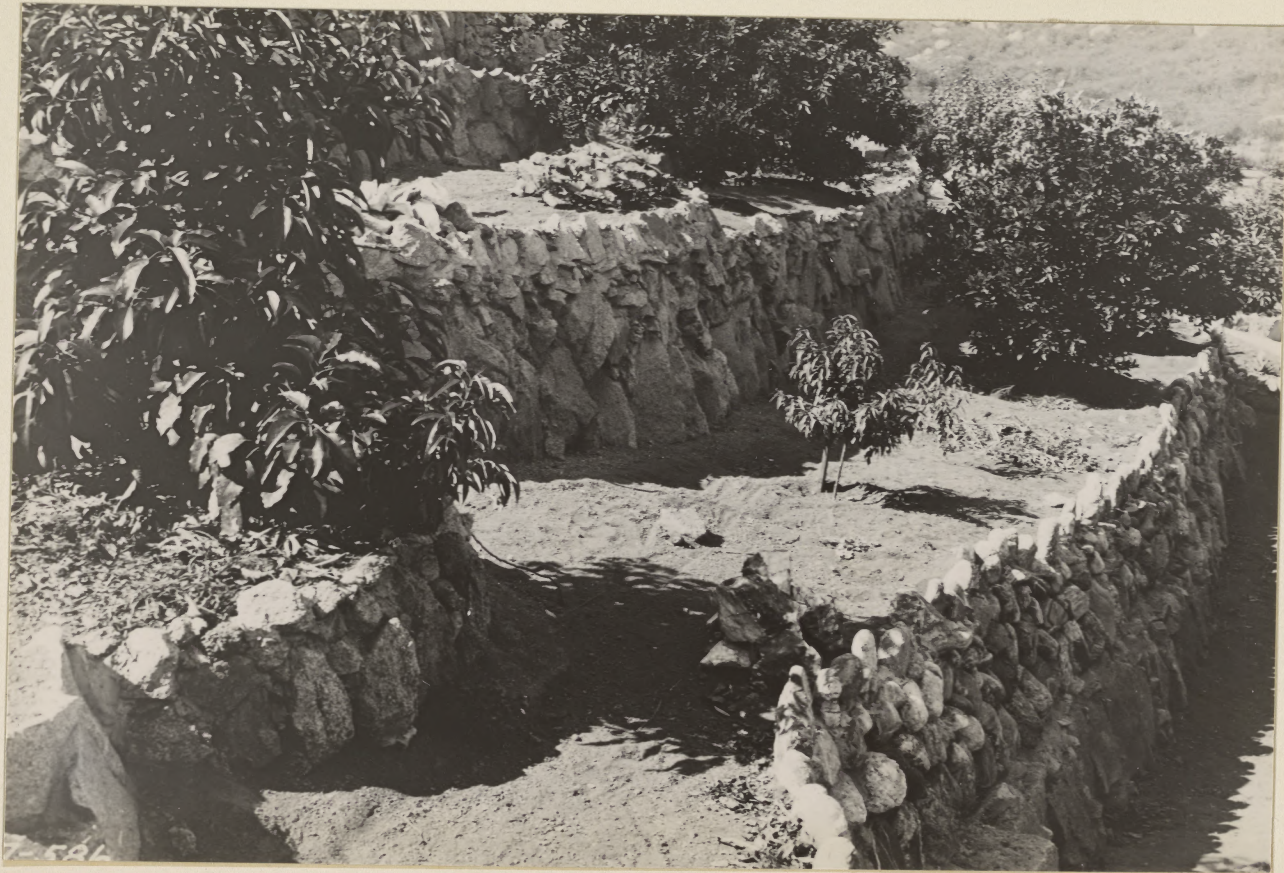
7-586 - Santa Paula, California.
EROSION CONTROL - Terracing.

In a few instances, provision is made against erosion in the Fallbrook Area as indicated in the picture above. 1934.

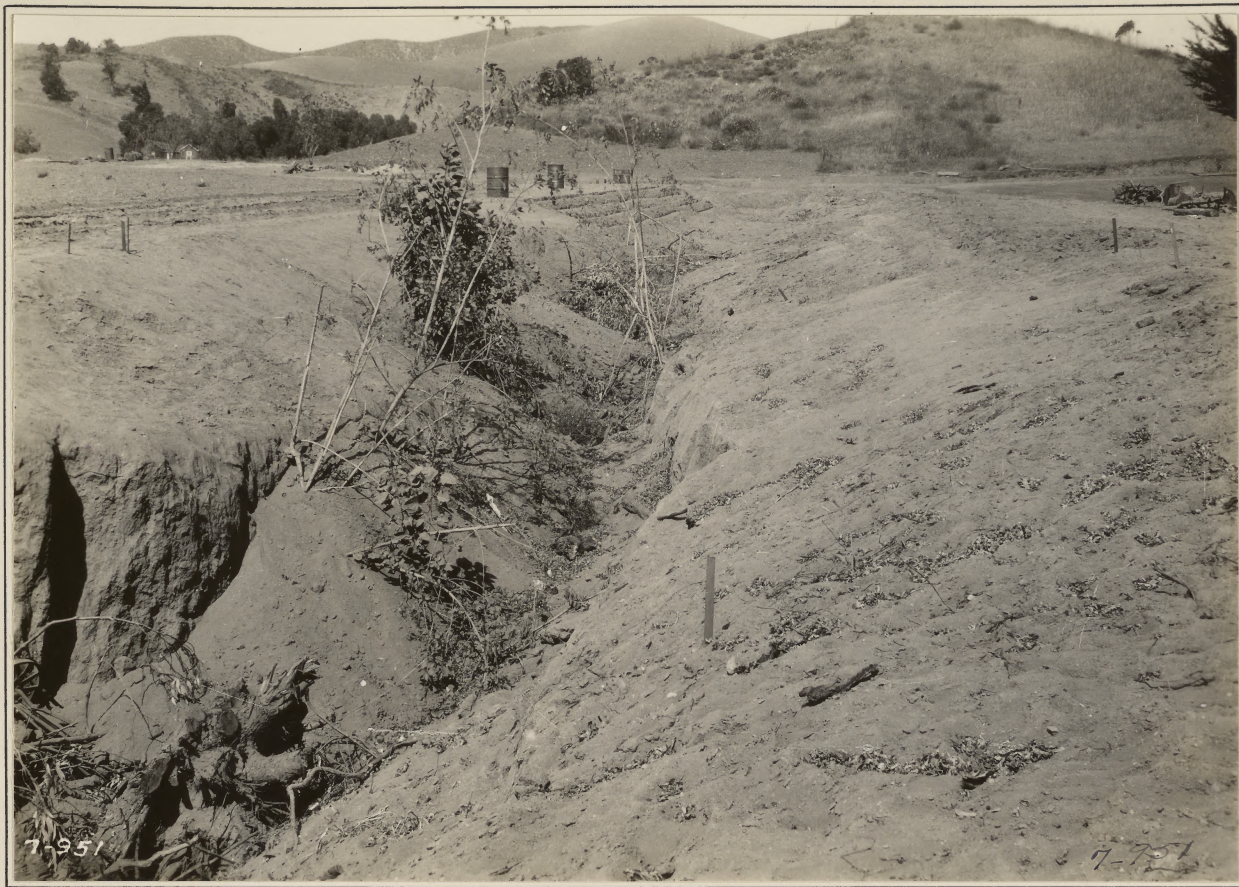
7-951 - Santa Paula, California
EROSION - Gully

A damsite before construction of wire and pipe dam. Banks have
been sloped preparatory to planting. 1934

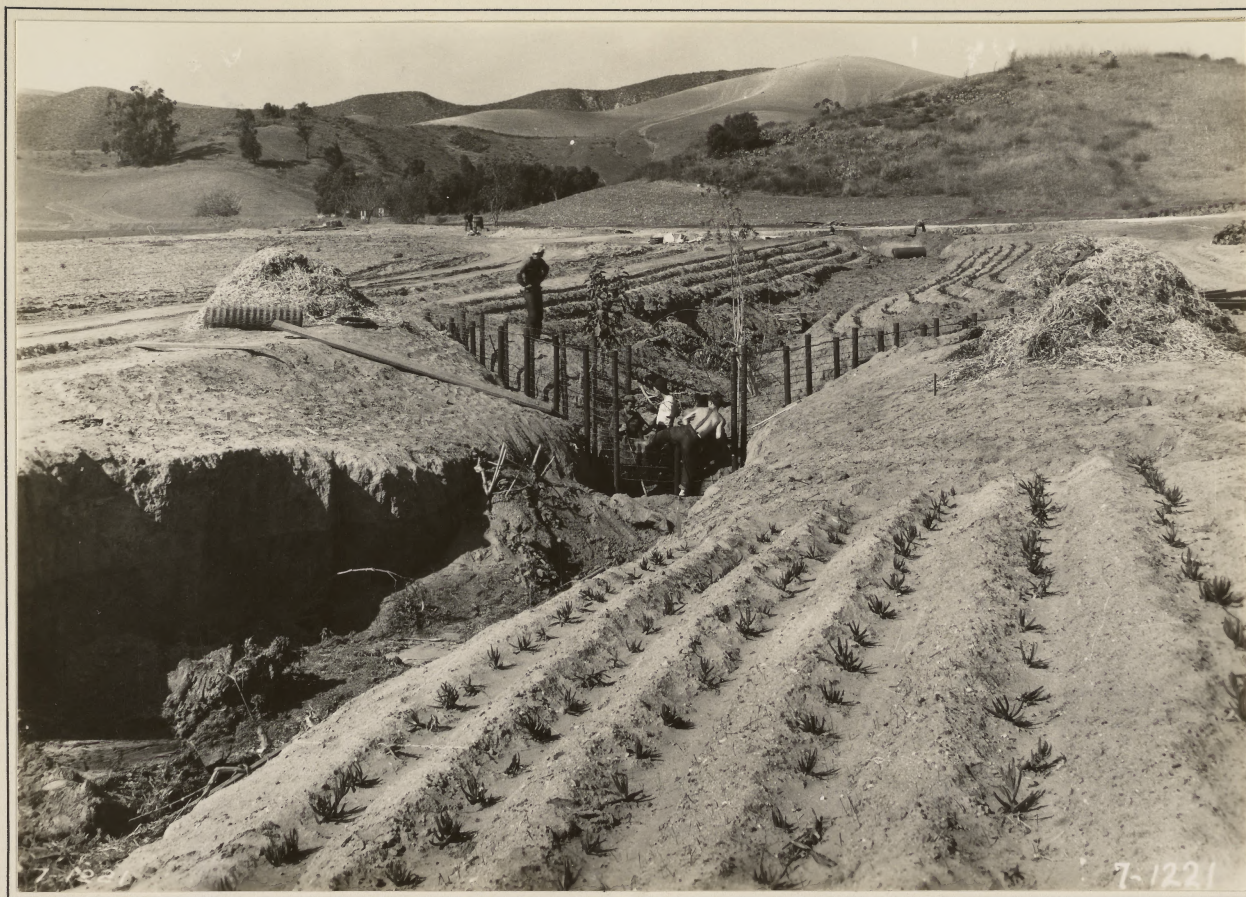
7-1221 - Santa Paula, California
EROSION - Gully - After

A later picture of 7-951. Note cagelike construction of pipe and wire mesh dam. Later a rock apron will be placed in front to prevent under cutting. 1934

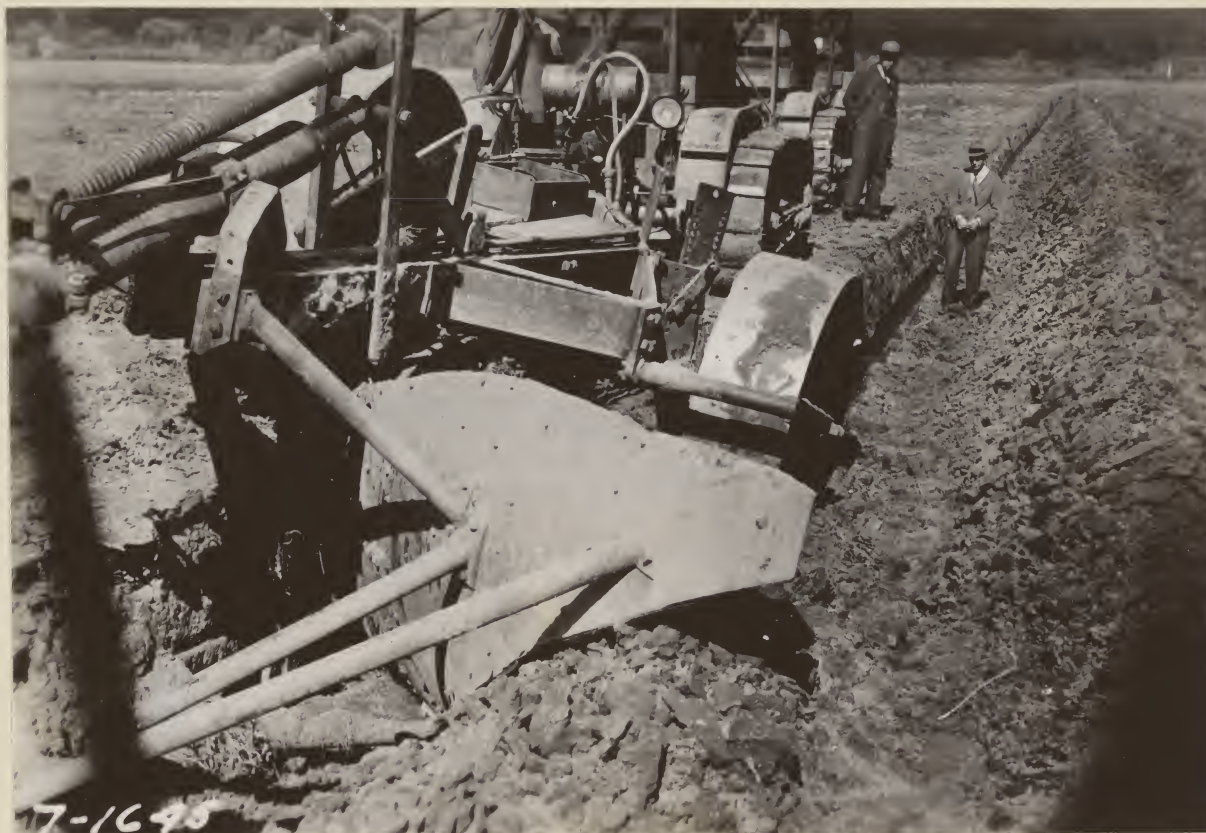
⁷
Cal-1645

View of the plow and the wide deep furrow it makes.

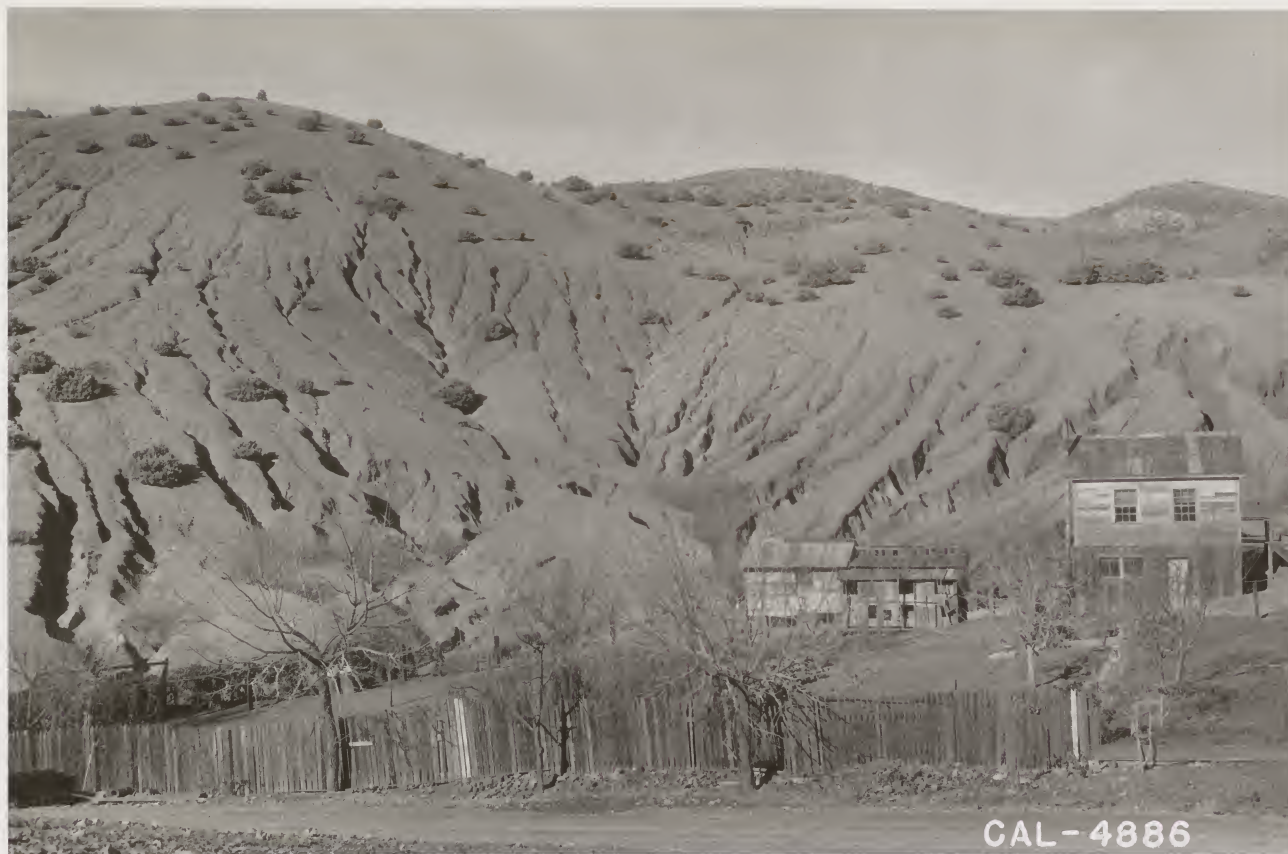
Cal. 4886 -- December 5, 1938 -- Shasta County, $\frac{1}{8}$ mi. S.E. of Kennett, California

Very severe sheet and gully erosion caused by complete denudation of vegetation from effects of old copper smelter. Located immediately upstream from Shasta Dam now being constructed.
Purpose of Photo: Flood Control Report.

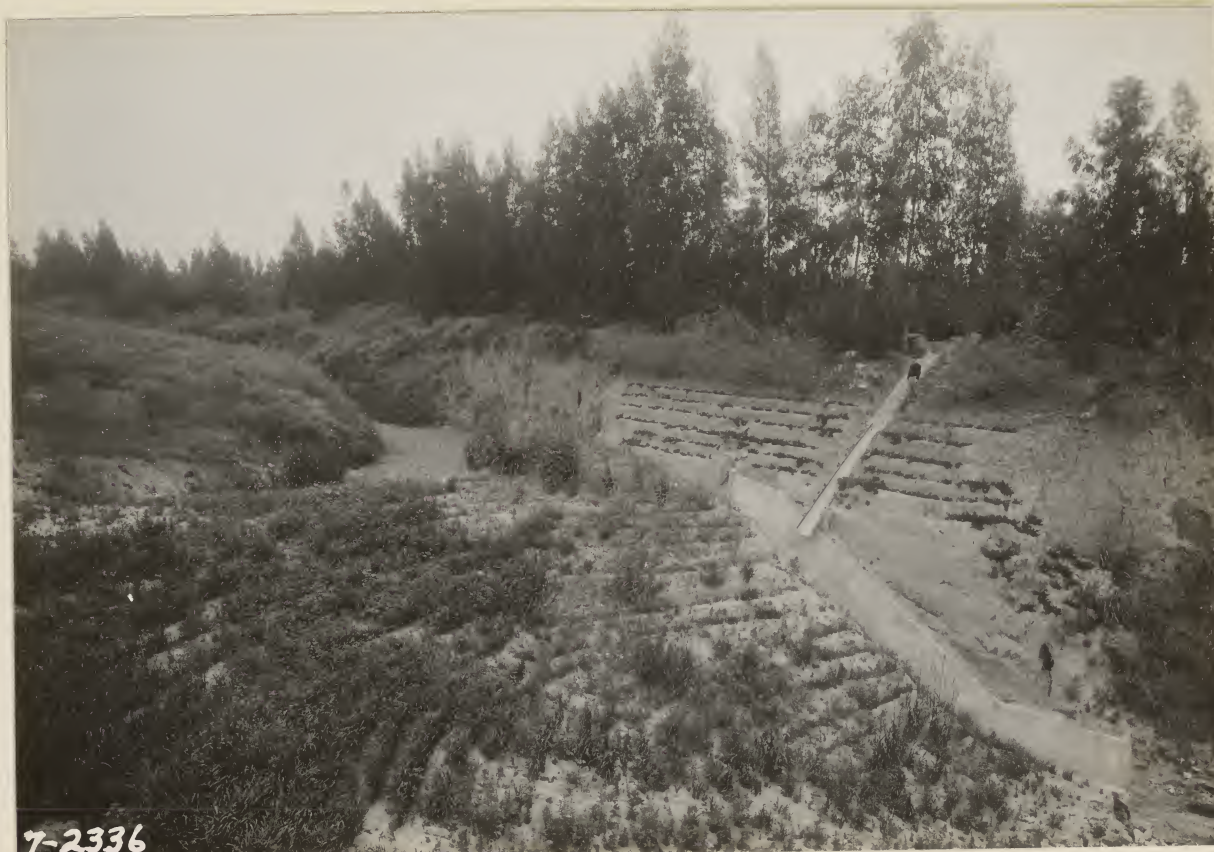
7-2336 - Santa Paula, California.
EROSION CONTROL - Gully Control.

A head control outfall #37 and large rock dam with a concrete facing #13, and surrounding planting.

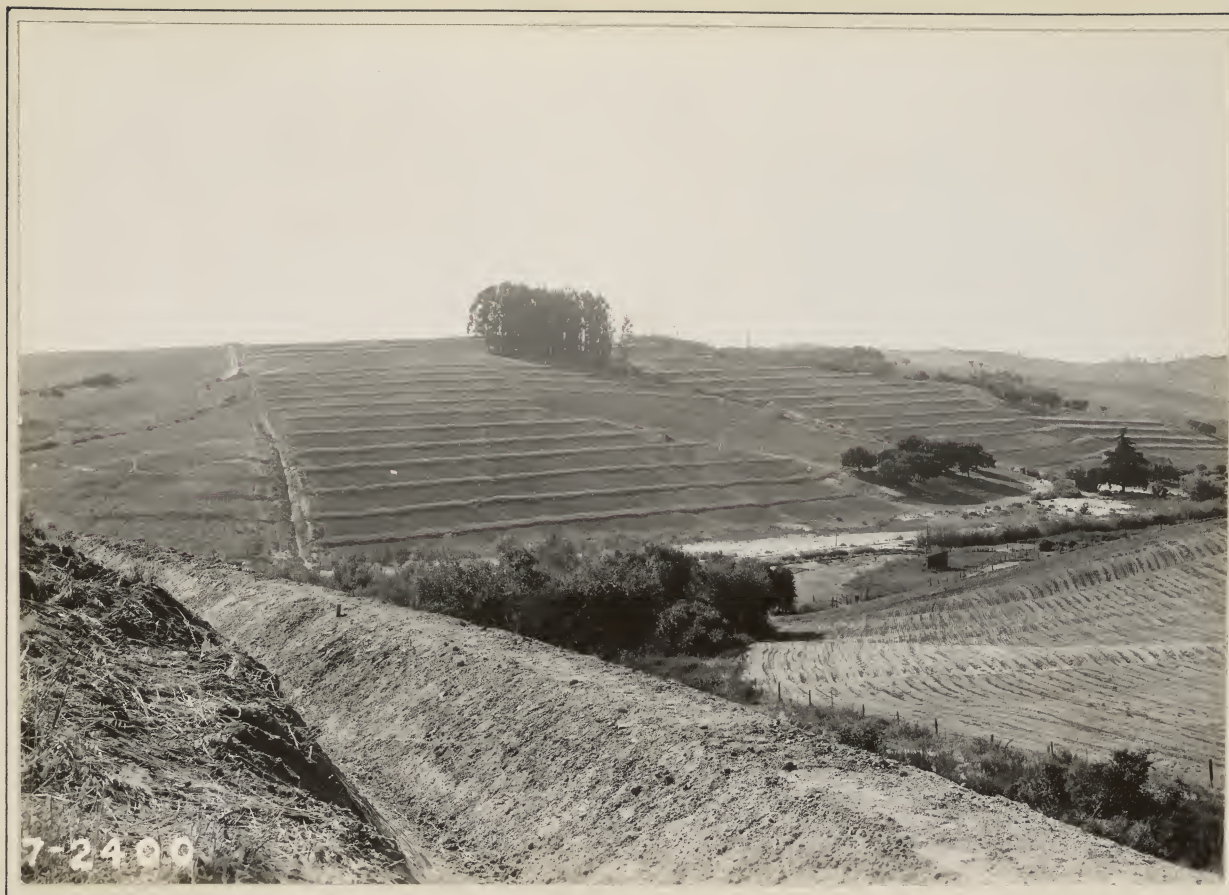
7-2400 - Santa Paula, California
EROSION CONTROL - Contour ditches

Contour ditches and diversion ditches - contour ditch bank in the foreground.

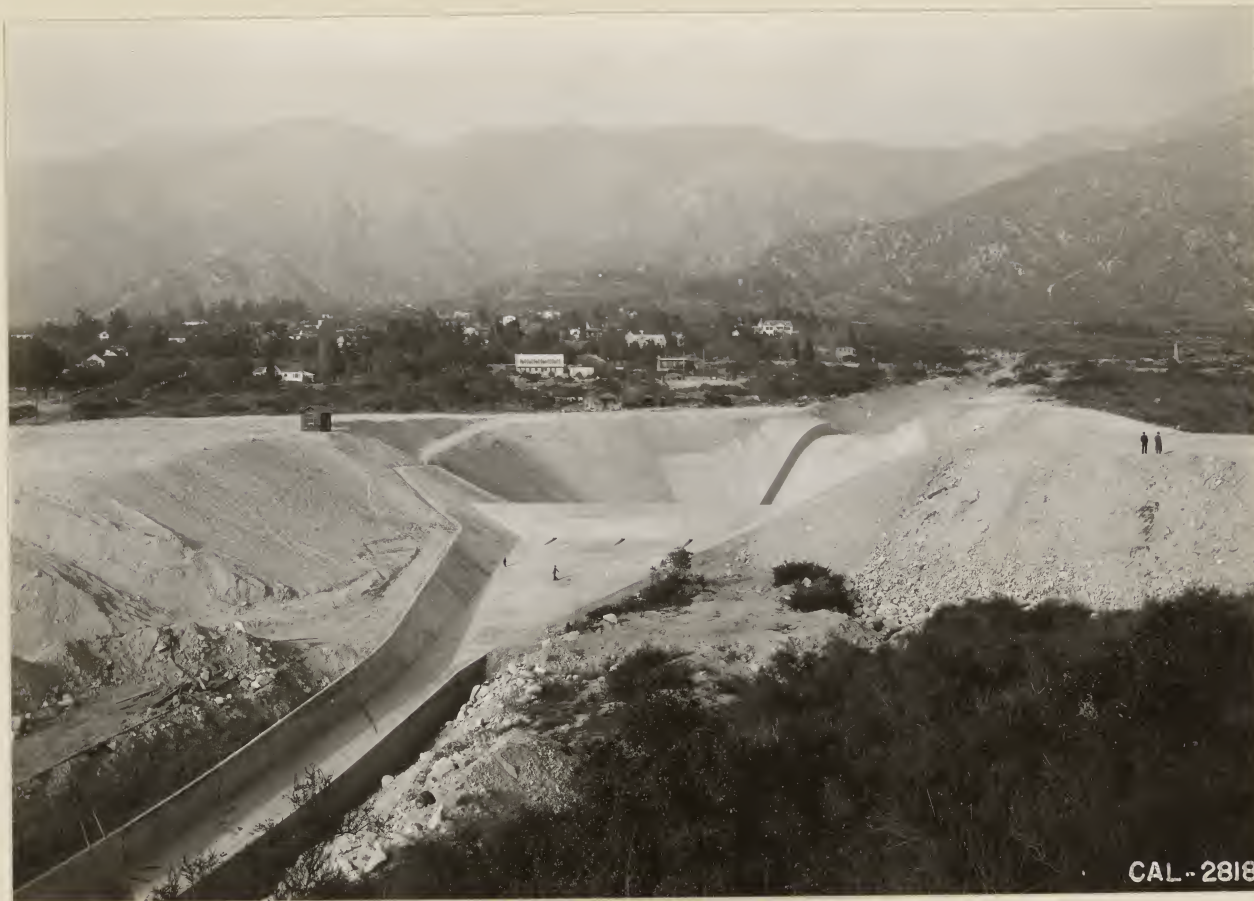
Cal-2818. California.

Completed Concrete debris basin at Montrose.

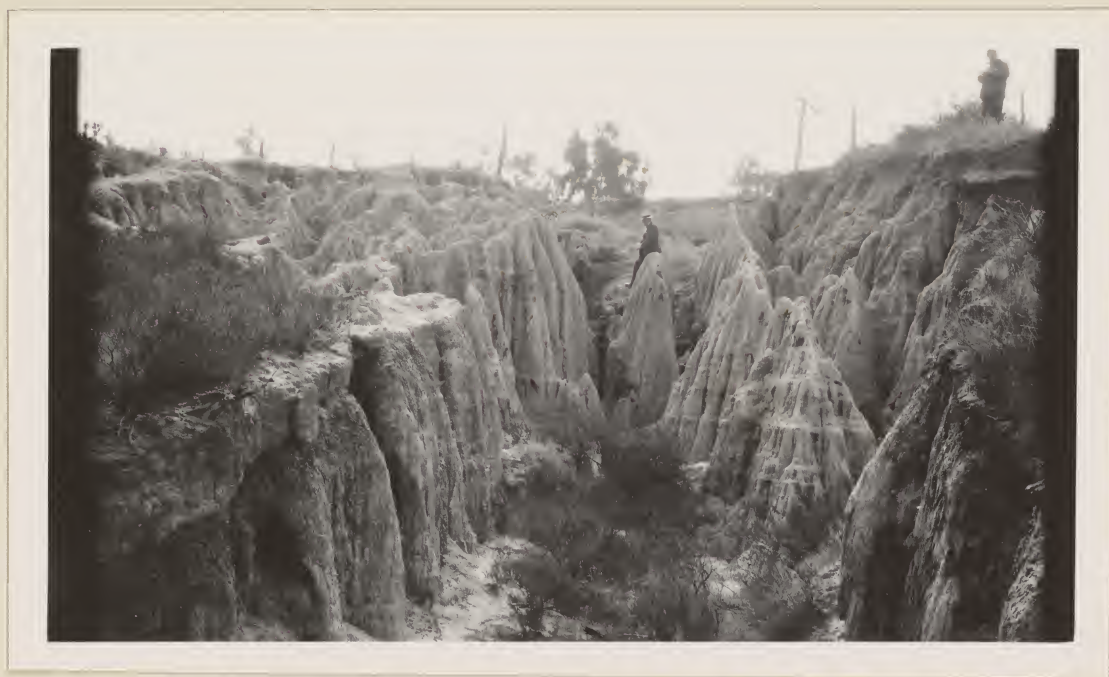
16844 - California.
EROSION - Gully.

Erosion in Lompoc Valley Section, south of Santa Maria, Calif.
This sandy clay formation is riddled with squirrel holes, which
no doubt have contributed to the washing. The highway at head
of gully is about to be undermined. H. H. Bennett - 1930.

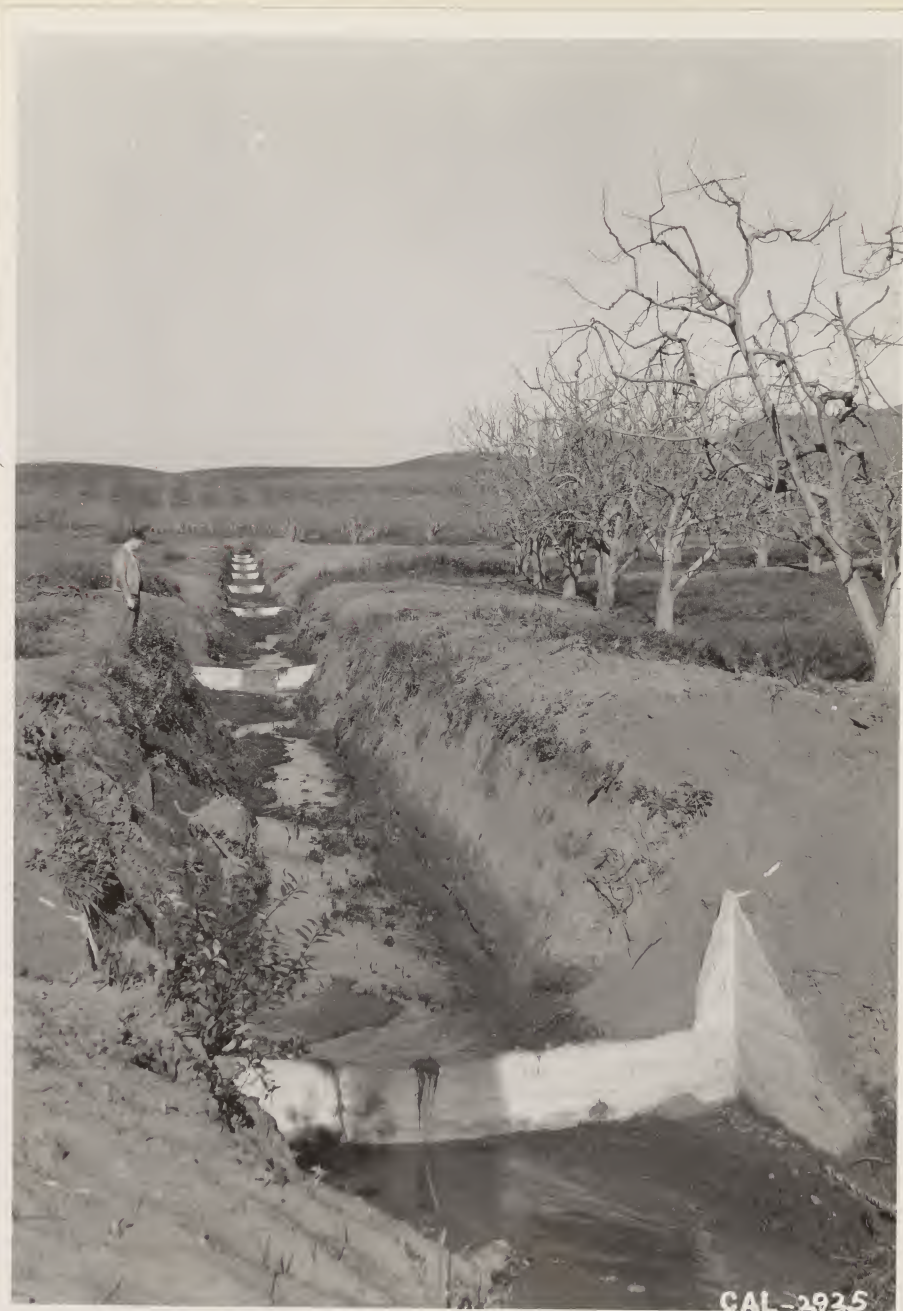
Part of a series of forty check dams in Pineo ditch. During the last rain all functioned perfectly with the exception of one which had been constructed at too low an elevation. See also No. Cal-2935. History: Original winding gully made a patch through this area of approximately 25 feet in width.

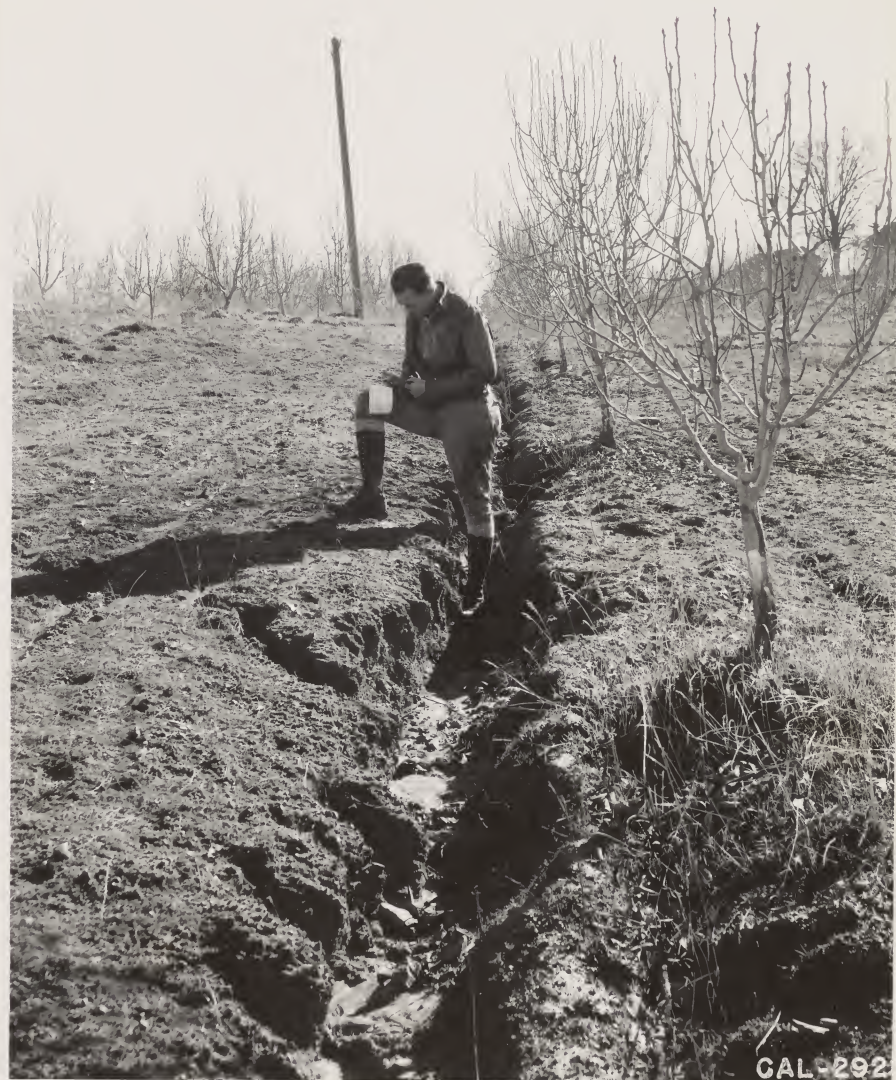
Cal-2928 El Dorado County 1-21-36
 Deep cutting in orchard caused by water follow-
 ing plowed furrows during the long period of
 continuous irrigation in the summer and by storm
 water in the winter.

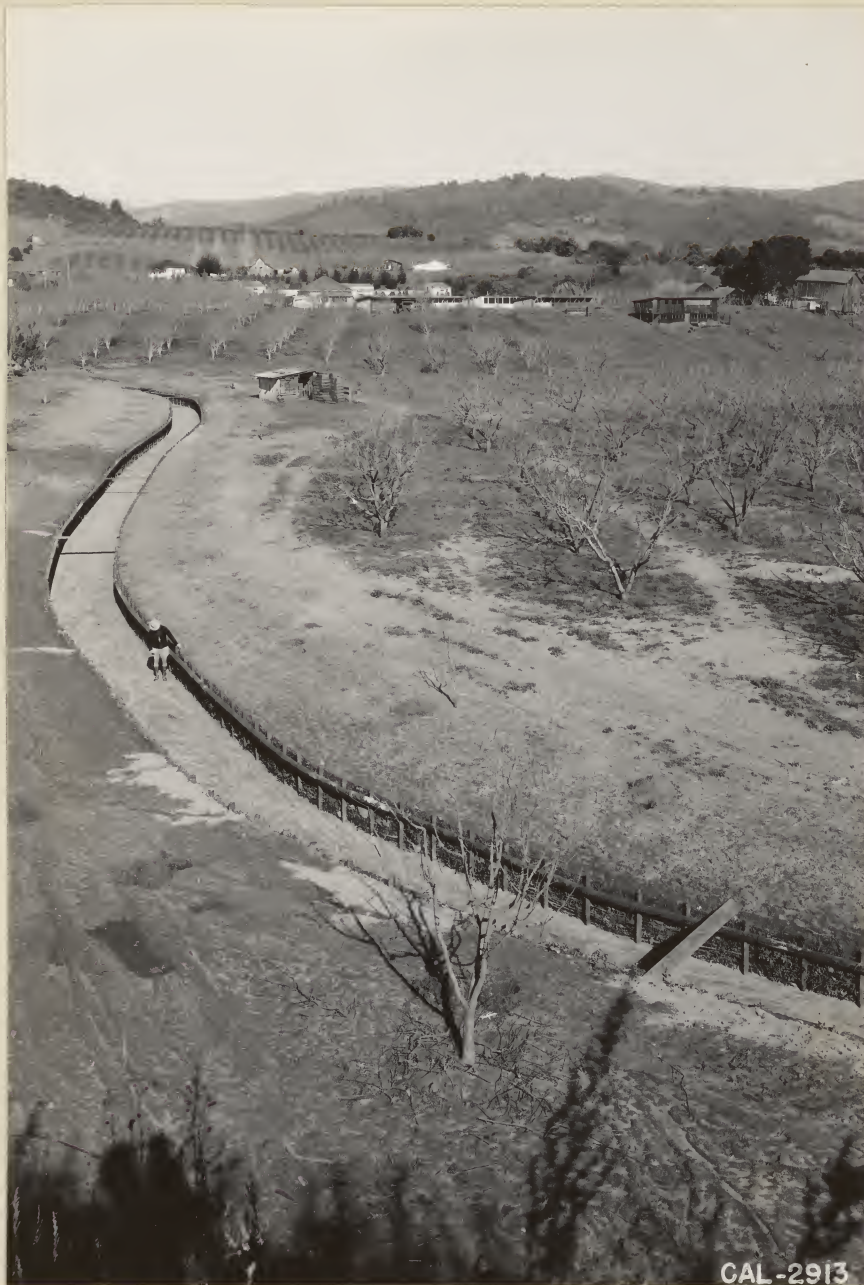
Cal-2913. California.
EROSION CONTROL.

Recently completed pipe and wire revetment control ditch which empties into Corralitos Creek. A close inspection will reveal a new row of tree holes made possible by this control. At upper end of ditch Ben Ceschi is planting all of the newly made available area along banks, a strengthening control and at the same time raising artichokes. Operation was perfect during recent rains. The owner furnished one hundred dollars for cement and is an enthusiastic booster of SCS activities. Previously this was an open gully.

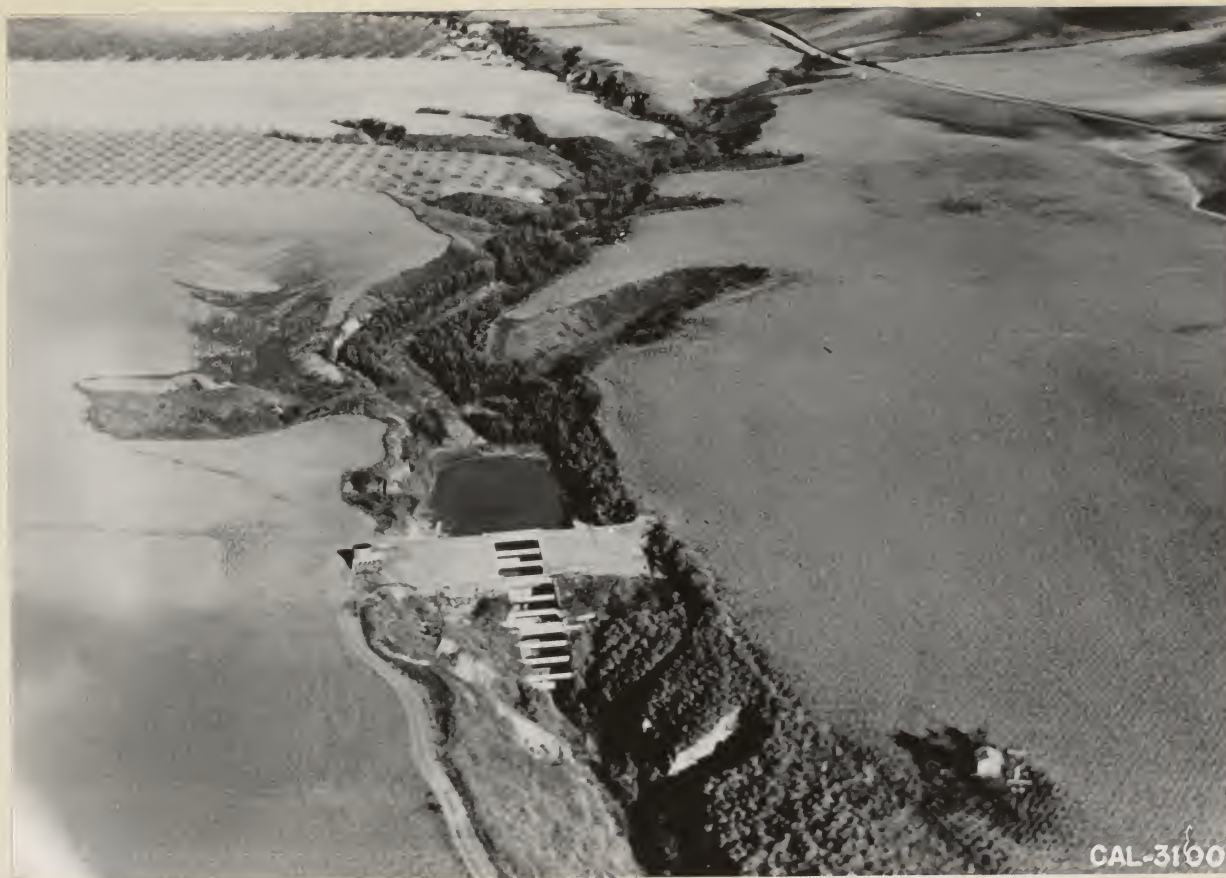
Cal-3100 - California.
Erosion Control - Dams.

The first two sections of this dam were built by the growers in 1927 and 1930. The third and last sections were built co-operatively by the growers and the SCS bringing the total height to 56 feet. March 20, 1936.

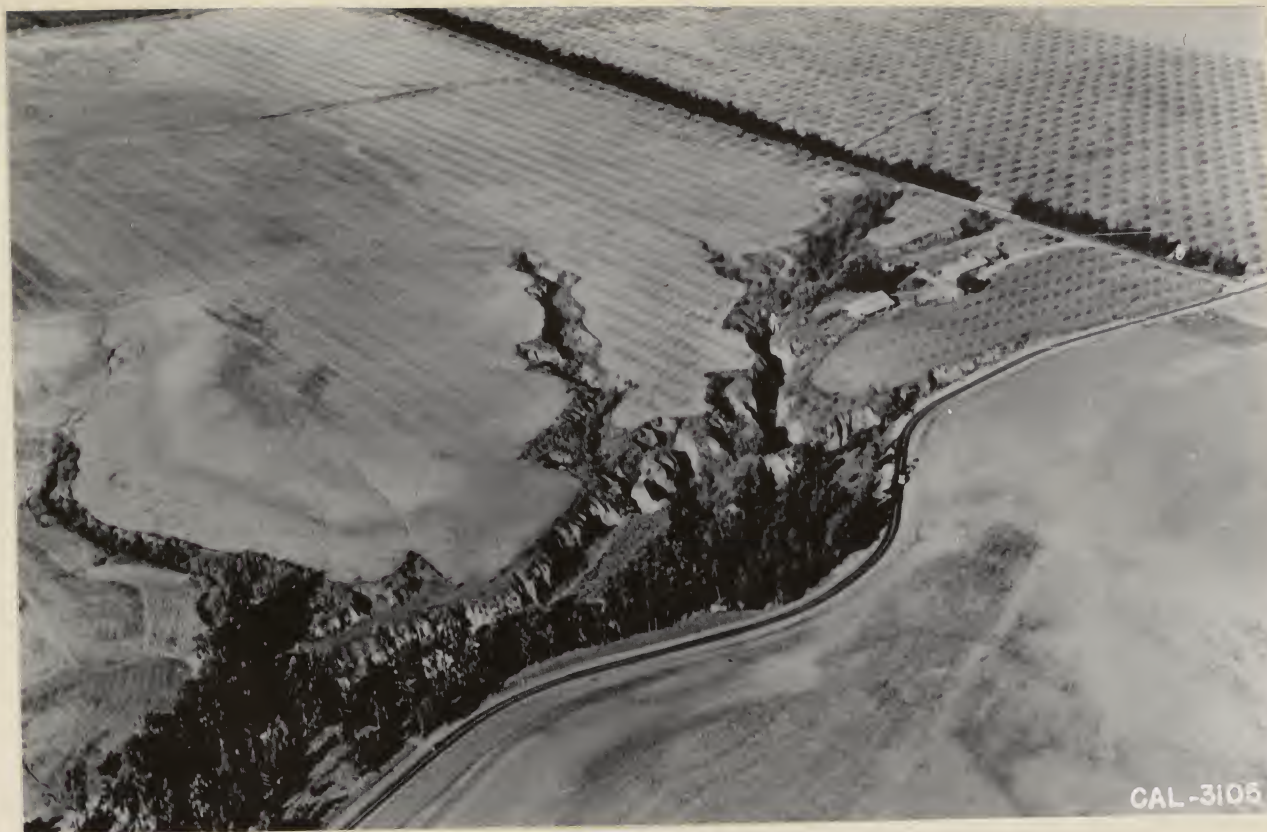
Cal-3105 - California.
EROSION - Gully.

Looking N over corner of La Vista and L. A. Ave. which may be seen to the right of the deep gully, portions of which are partially stabilized by vegetation. An excellent example of fingering. March 20, 1936.

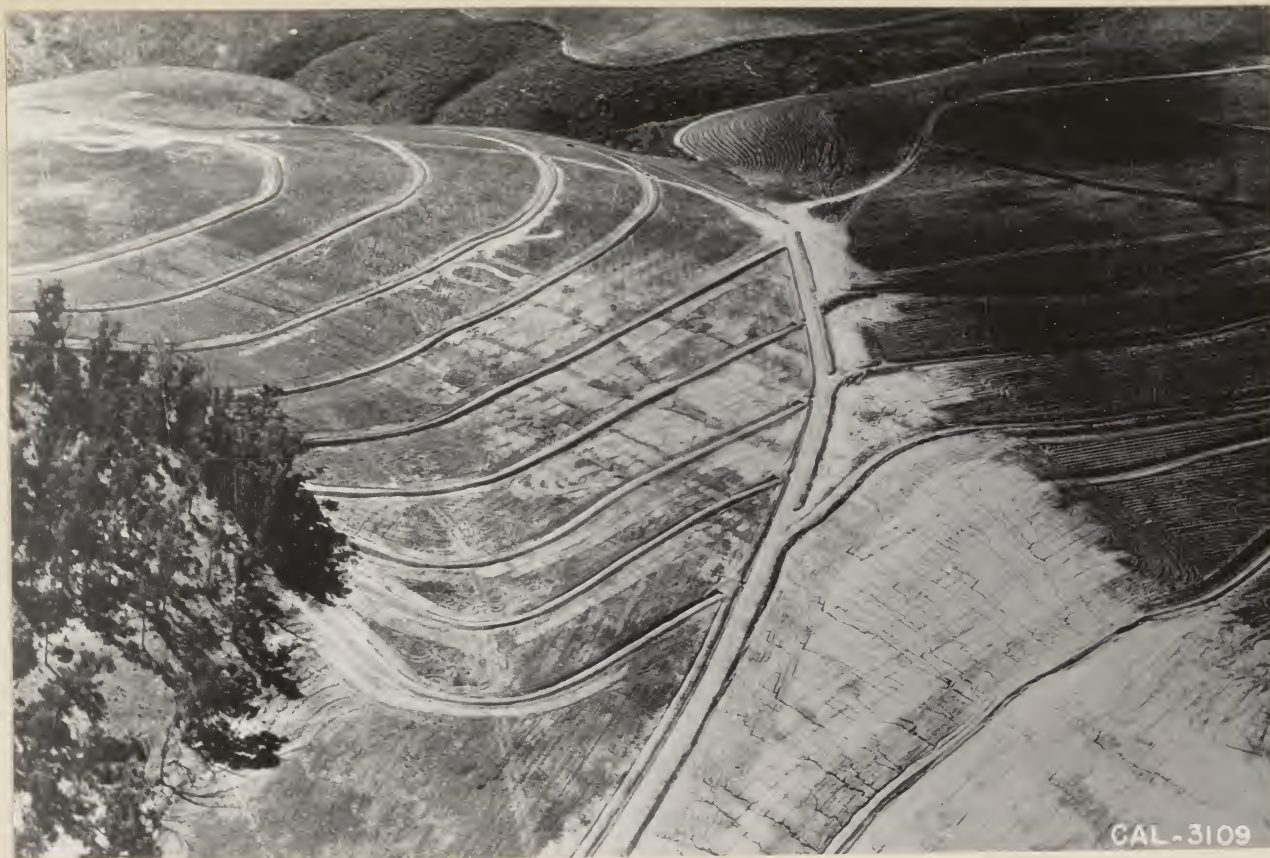
Cal-3109 - California.
EROSION CONTROL - Terraces.

Narrow-base terraces constructed by the SCS. The whole field except that part shown in the lower right corner was subsoiled and came through a heavy rain with very little soil loss. The light colored portion on which rilling is plainly seen was used. This strikingly illustrates the effectiveness of subsoiling.

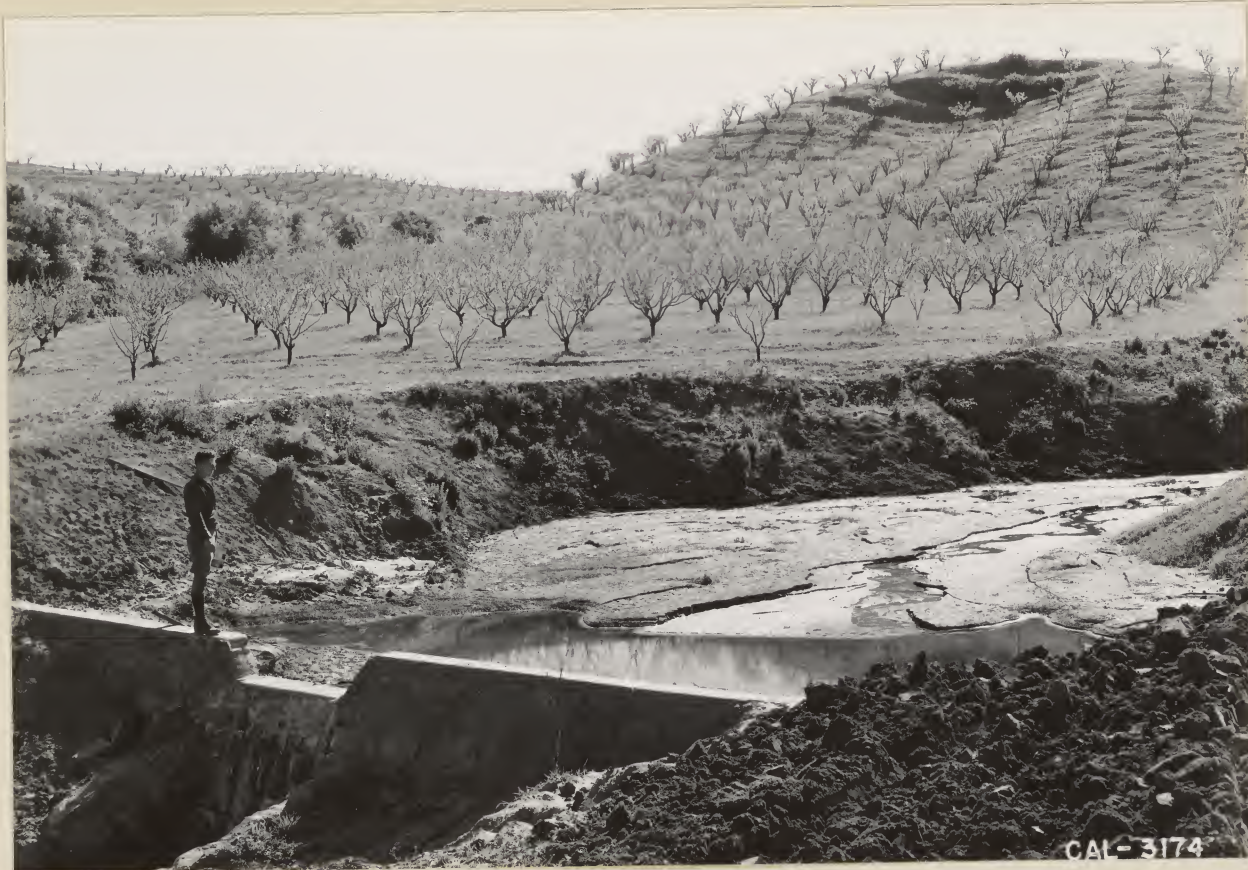
Cal-3174 - California.
EROSION CONTROL - Check Dam.

Silting behind rock masonry check dam. Probable that lip and crest will be raised. Gully was widening and deepening rapidly previous to 6' of silt deposit shown.

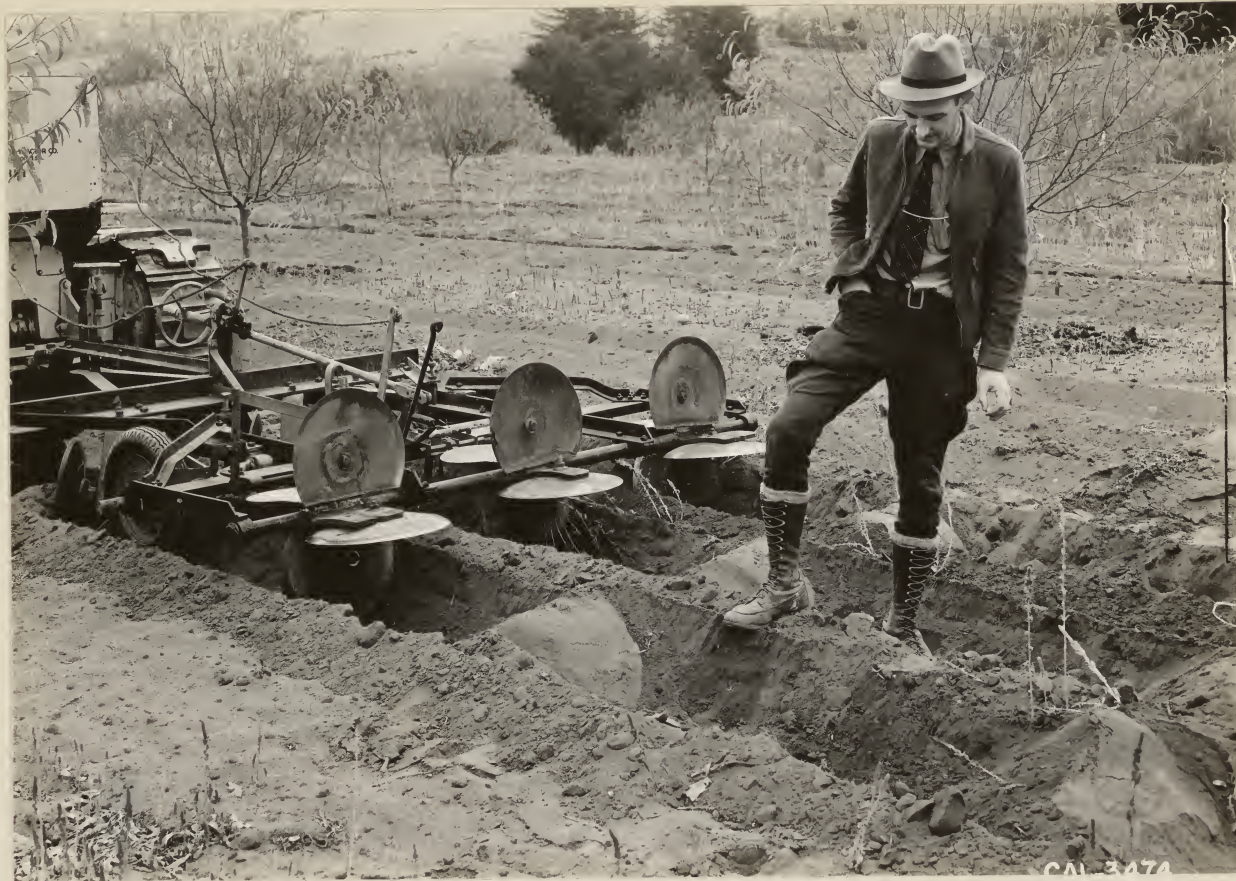
Cal-3474. California.
EROSION CONTROL - Listing.

Improvements on this basin-lister were developed by the Corralitos Project to fill a need for an inexpensive method of controlling surface run-off. Note the dams at 4 foot intervals instead of the usual 10 or 12 feet. 10/20/36.

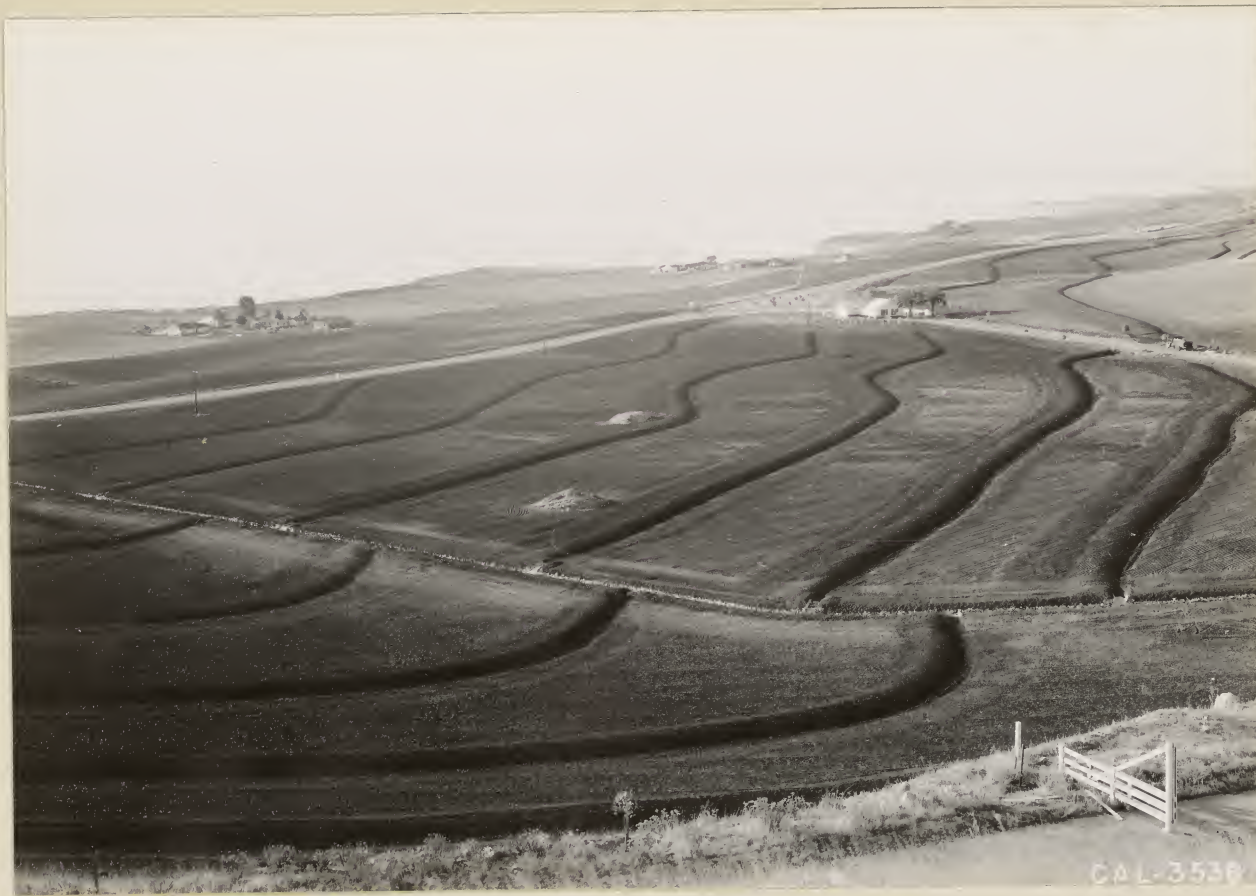
Cal-3538. California.
EROSION CONTROL - Terraces.

Broad-base terraces have been constructed and a loose rock lined terrace outlet is now complete.
